Air Inlet Installation & Inspection Report

Site Name: FP & L Plant Sanford

Designation: 5B CT Inlet Duct & Filtration Inspection

4D & 4C Inlet Inspection and Cleaning

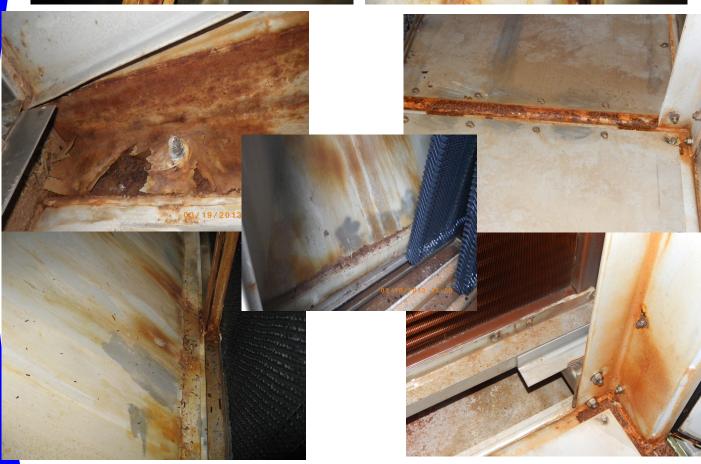
Rust and corrosion $\underline{\text{must}}$ be addressed. If it is not, manufacturer should strongly consider voiding the warranty.

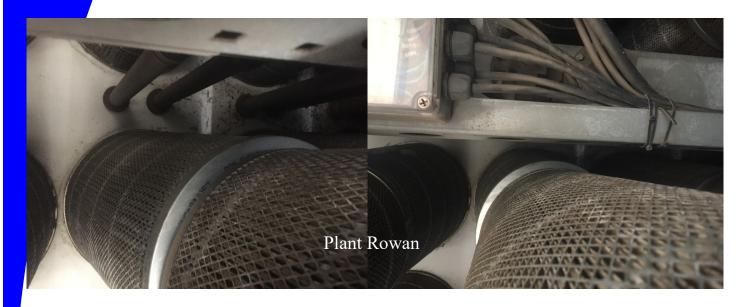
Misalignment of filters results in improper sealing of the gasket which causes bleed-by.

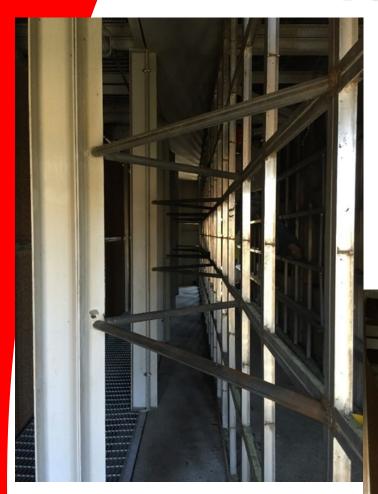
With increased air flow and multiple GE modifications that are available at this time, it can result in bowing of the existing T-grid which will allows bleed-by. Reference next page for examples.

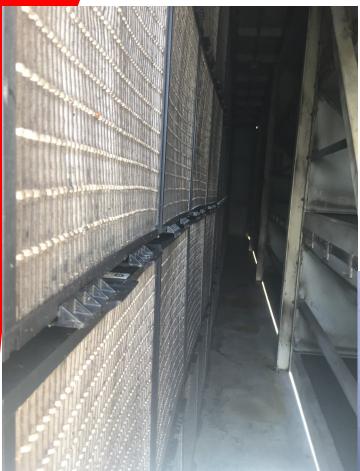
This is a Braden inlet with 4-point hardware and T-Grid in front of a GE 7F.05 upgrade. The framing is insufficient between the clean side stand offs. Please refer to previous page for examples T-grid.

We suggest replacing the T-Grid with vertical columns to be 2" SS 11 gauge with ½" flanges at floor and ceiling. The vertical tubing to be stabilized with 2" SS tubing from each floor level out to tubing. This mitigates the need for extensive hardware for 4-point mounting.

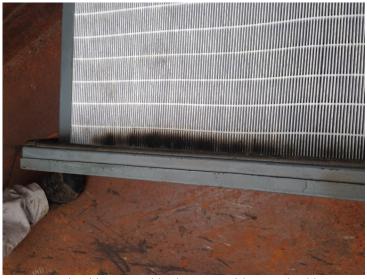
5B: Bleed by caused by bent T-Grid. Repaired by Filter-Doc before installation of new filters.

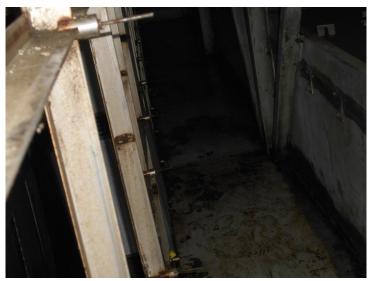
5B: All anchors inspected and repaired prior to installation of new Gore filters.

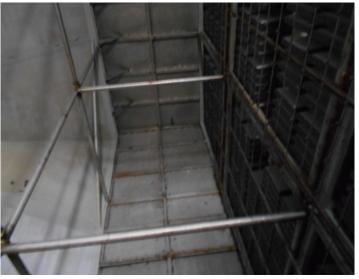
5B: Fogger system inspected and in fair condition.

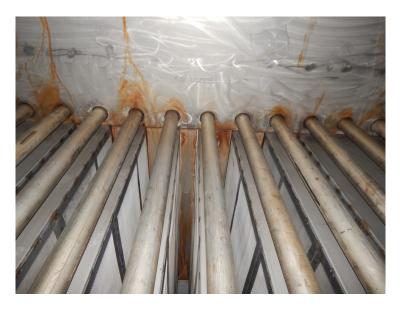
5B: Downstream leaks at front and back side of silencer section flanges. Cleaned and repaired by Filter-Doc.

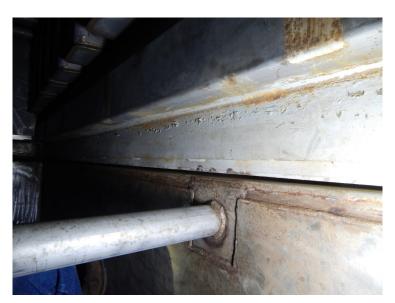
5B: Bleed heat/black side of silencer inspection.

Flaking paint and rust. Scraped and vacuumed per FP & L's instructions.

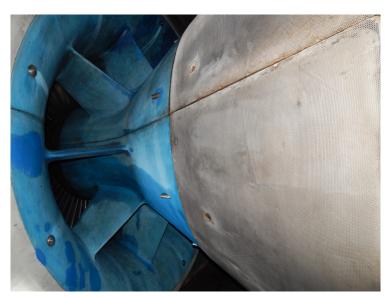
5B: Bellmouth inspection.

Bellmouth in fair condition with light flaking. Cleaned and wiped down by Filter-Doc.

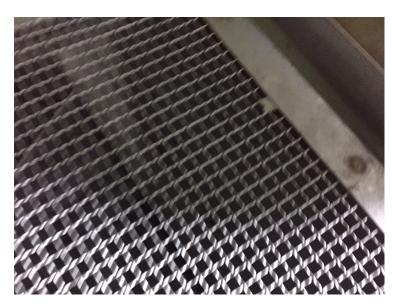
5B: Duct screens inspected. Little to no debris, small flakes of paint.

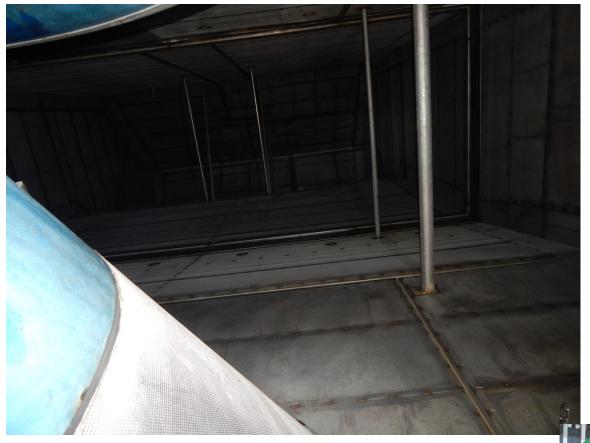
5B: Inlet duct inspection. Duct in very good condition. No light bleed through or debris.

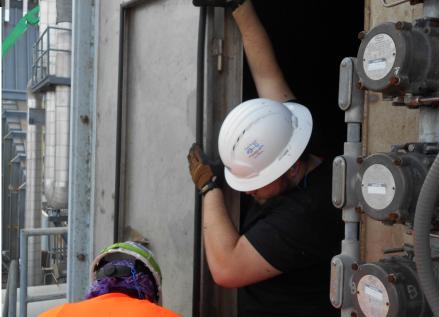
5B: Inlet door to fogger area. Bad gasket replaced by Filter-Doc.

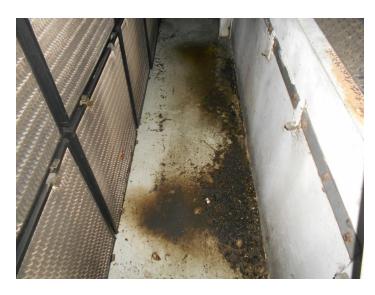
4D: Inlet pre-filters in fair condition. Return hardware inspected and in good condition. Dirty side inlet floor dirty and rusting.

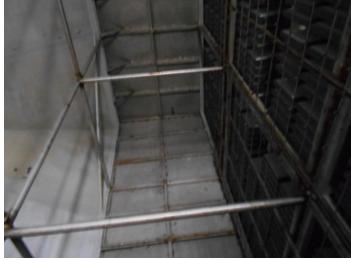
4C & 4D: Fogger system visually inspected. Looks to be in good condition.

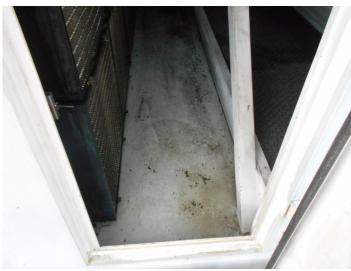
4C & 4D: Dirty air side after inspection. Cleaned and scraped by Filter-Doc.

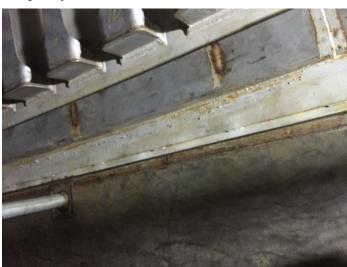
4C & 4D: Back side of silencer had flaking paint. Filter-Doc scraped and cleaned per FP & L.

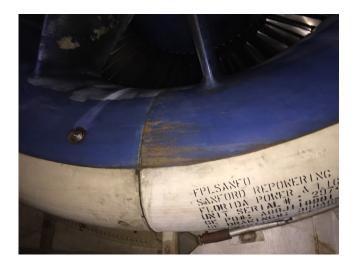
4C & 4D: Bellmouth typical in each inlet. Dirty with minor flaking.

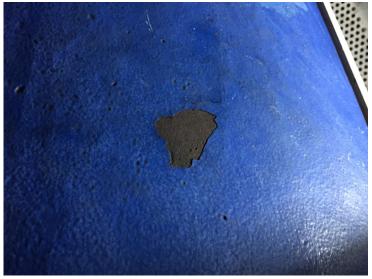
4C & 4D: Bellmouth flaking.

In summary, both 4D and 4C were in poor condition. At a later date, Filter-Doc recommends complete blasting and coating of each inlet. There is a lot of rusting and corrosion in each inlet from the hoods to the back side of the filter T-Grid. Filter-Doc also recommends replacing the ME panel in each of the inlet hoods. At the time of inspection, the T-Grid appeared to have a slight bow that needs to be repaired when new filters are installed.

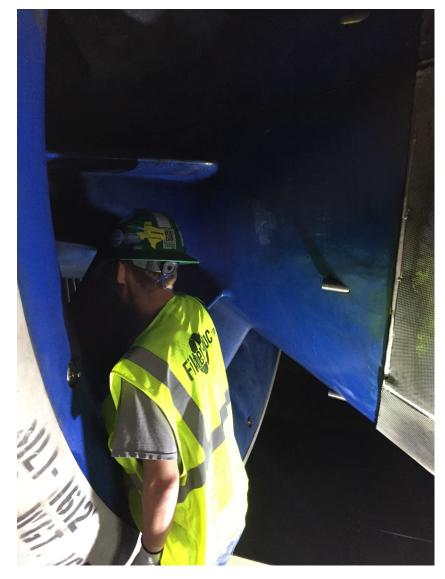
4C & 4D: Each bellmouth was cleaned and scraped by Filter-Doc per FP & L.
